From: Todd Hanke <THanke@onterra-eco.com>
Sent: Friday, June 25, 2021 3:14 PM
To: dbursik@new.rr.com
Cc: Tim Hoyman; Josephine Barlament
Subject: Horsehead Lake June 2021 Early-Season AIS Survey Results
Attachments: Horsehead_CLP_June21.pdf; Map8_Horsehead_CLP_June17.pdf

Horsehead Lake
Oneida County, Wisconsin
June 2021 CLP
Survey Locations

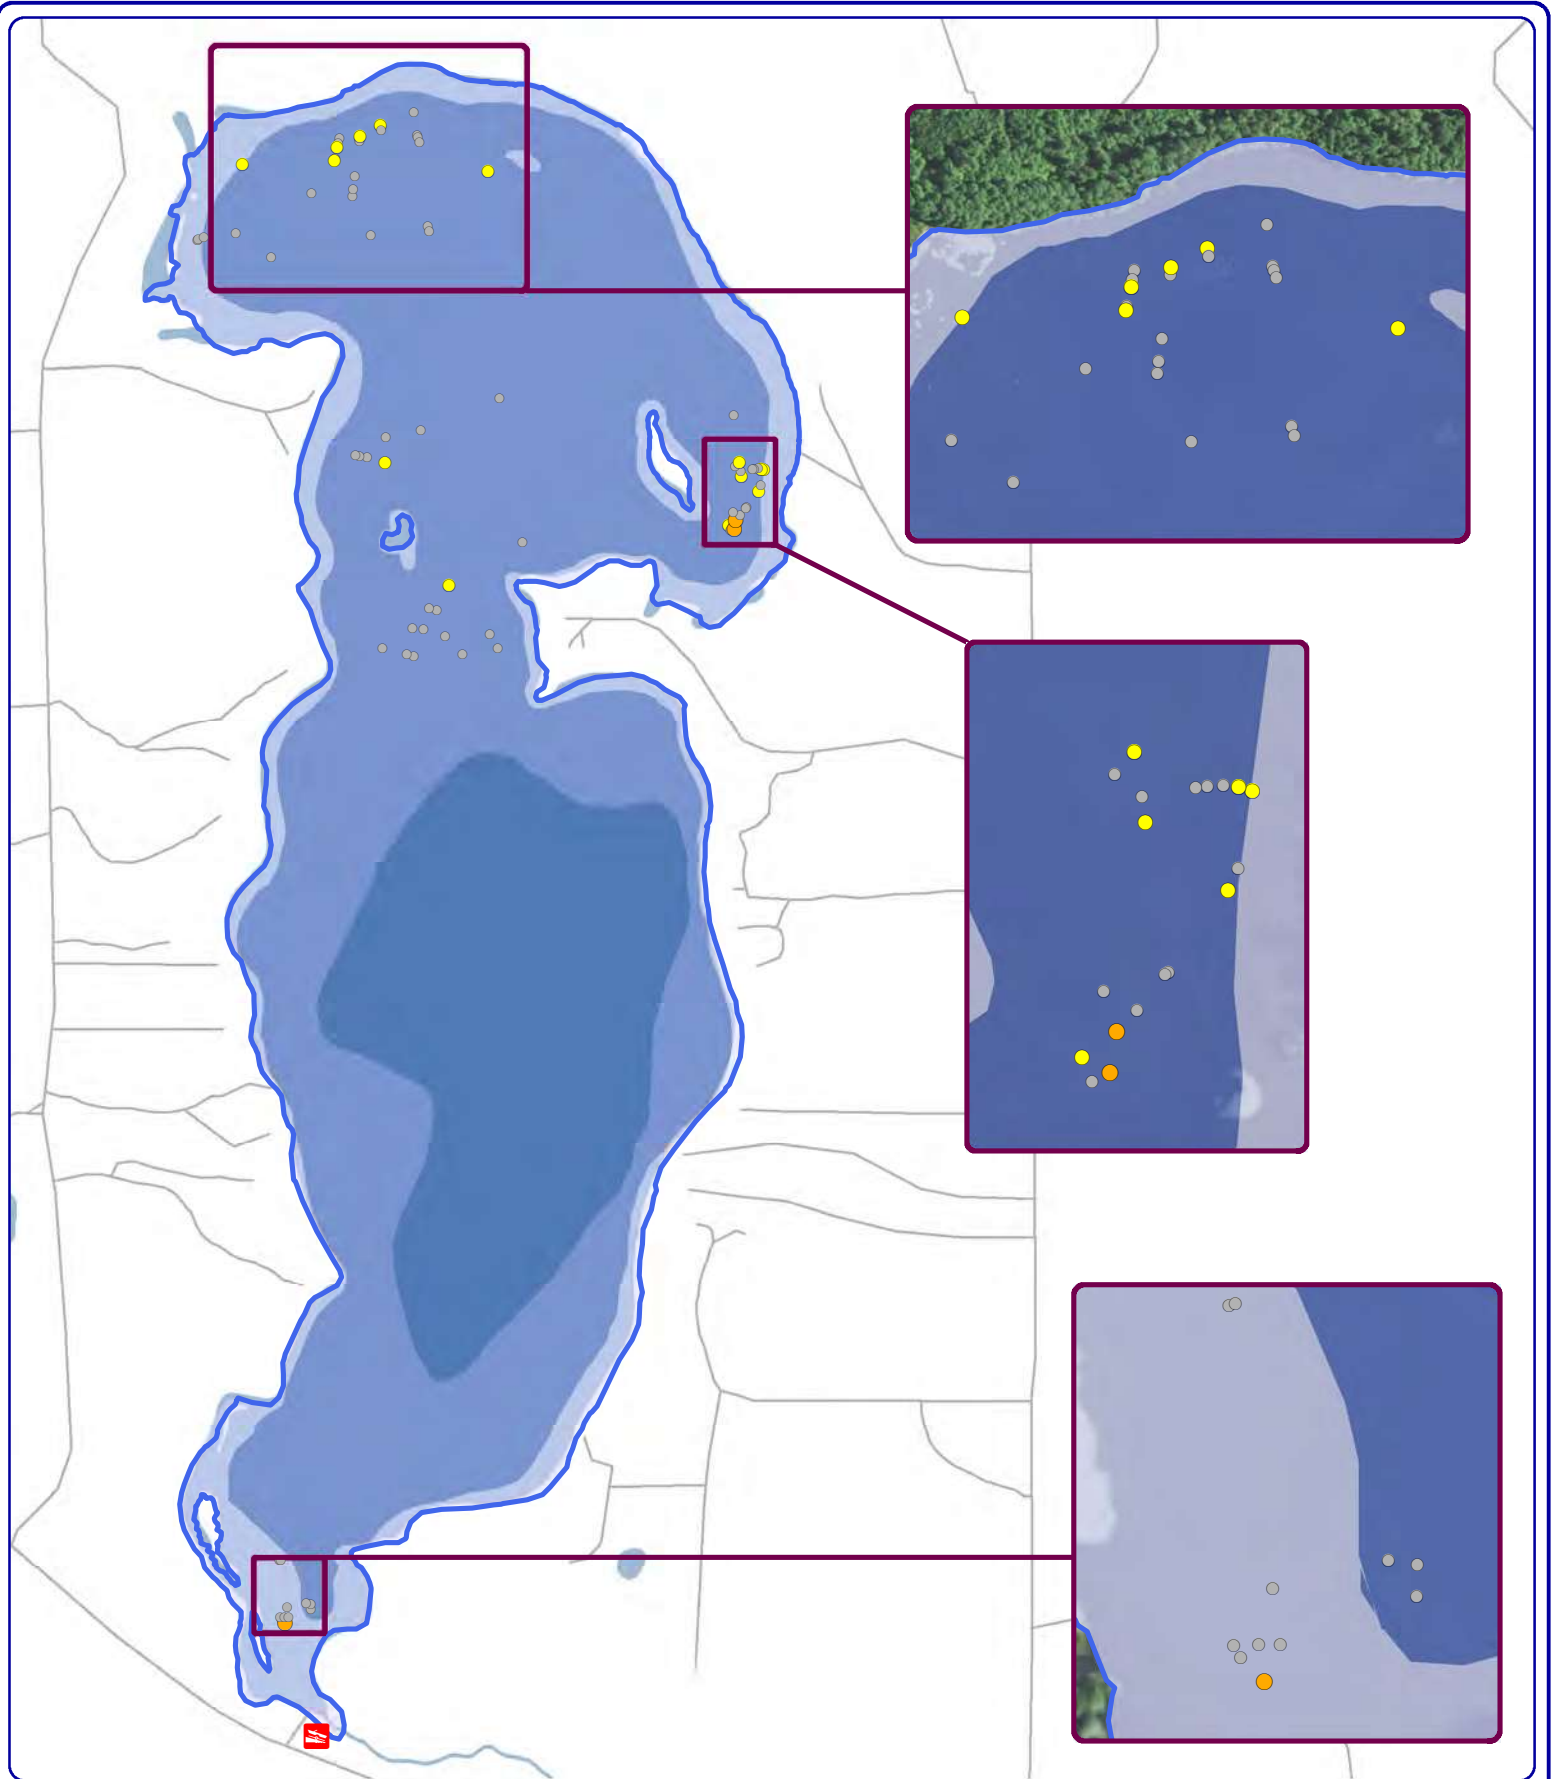
The attached PDF map ***Horsehead_CLP_June21.pdf*** displays the results of the CLP mapping survey. All CLP was mapped either as single or few plants, clumps of plants, or small plant colonies. No large and contiguous colonies that required area-based mapping methodologies, were located anywhere in the lake. Most of the CLP was in the northern half of the lake, however some was also located towards the southern end of the lake just north of the boat landing. I've also attached the 2017 CLP map for comparison (***Map8_Horsehead_CLP_June17.pdf***). Slightly less CLP was mapped in 2021 compared to 2017. CLP populations are variable from year to year, often fluctuating based on environmental factors including ice-out date, winter snow cover, spring water temperatures etc. Overall, the CLP population in Horsehead Lake is considered low and not likely to be causing any negative impacts to the ecology of the lake or impacts to user activities such as boating.

Our crews did not map any EWM in the lake. Crews did note the presence of a fair amount of the native northern watermilfoil around the lake that appeared bright green in color. Towards the southern end of the lake, we collected two samples of milfoil plants that looked a little different than the northern watermilfoil elsewhere in the lake and exhibited some characteristics consistent with hybrid watermilfoil (HWM), a cross between EWM and northern watermilfoil. Distinguishing between northern watermilfoil and hybrid watermilfoil with confidence is challenging in a field setting. In order to determine whether these specimens are HWM or native, DNA analysis is necessary. We have processed the plants at our office and will be working with WDNR partners to see about getting DNA analysis completed. We expect it would be a matter of months before these analysis results would be available. In the meantime, there is no need to follow-up with a hand harvesting effort this year.
